UNDERWATER INSPECTION REPORT

BRIDGE NAME:	Waverley Lake Outlet	REGION:	2	BRIDGE NUMBER:	43C08	
RIVER NAME:	Cox Creek	OWNER:	City of Albany	DISTRICT:	4	
STATE HWY #:		ROUTE NUMBER:		MILE POINT:	0	
COUNTY:	Linn	ROAD NAME:	Salem Ave.		VISIBILITY (Ft.):	1
FOUNDATION TYPE:		ACCESS:	3&2	WATER TEMP:	55	
DIVERS:	Shorb, J.Ottosen, Goff, Boothe		INS. INTERVAL:	1	MAXIMUM DEPTH:	10-ft.
Water Elevation	Lake elevation was at 0.7-ft. on elevation board. Stream was 3.0' above top of apron (see sketch)

43C08 Waverly Lake Outlet - Salem Ave MP 0.0 (City of Albany)

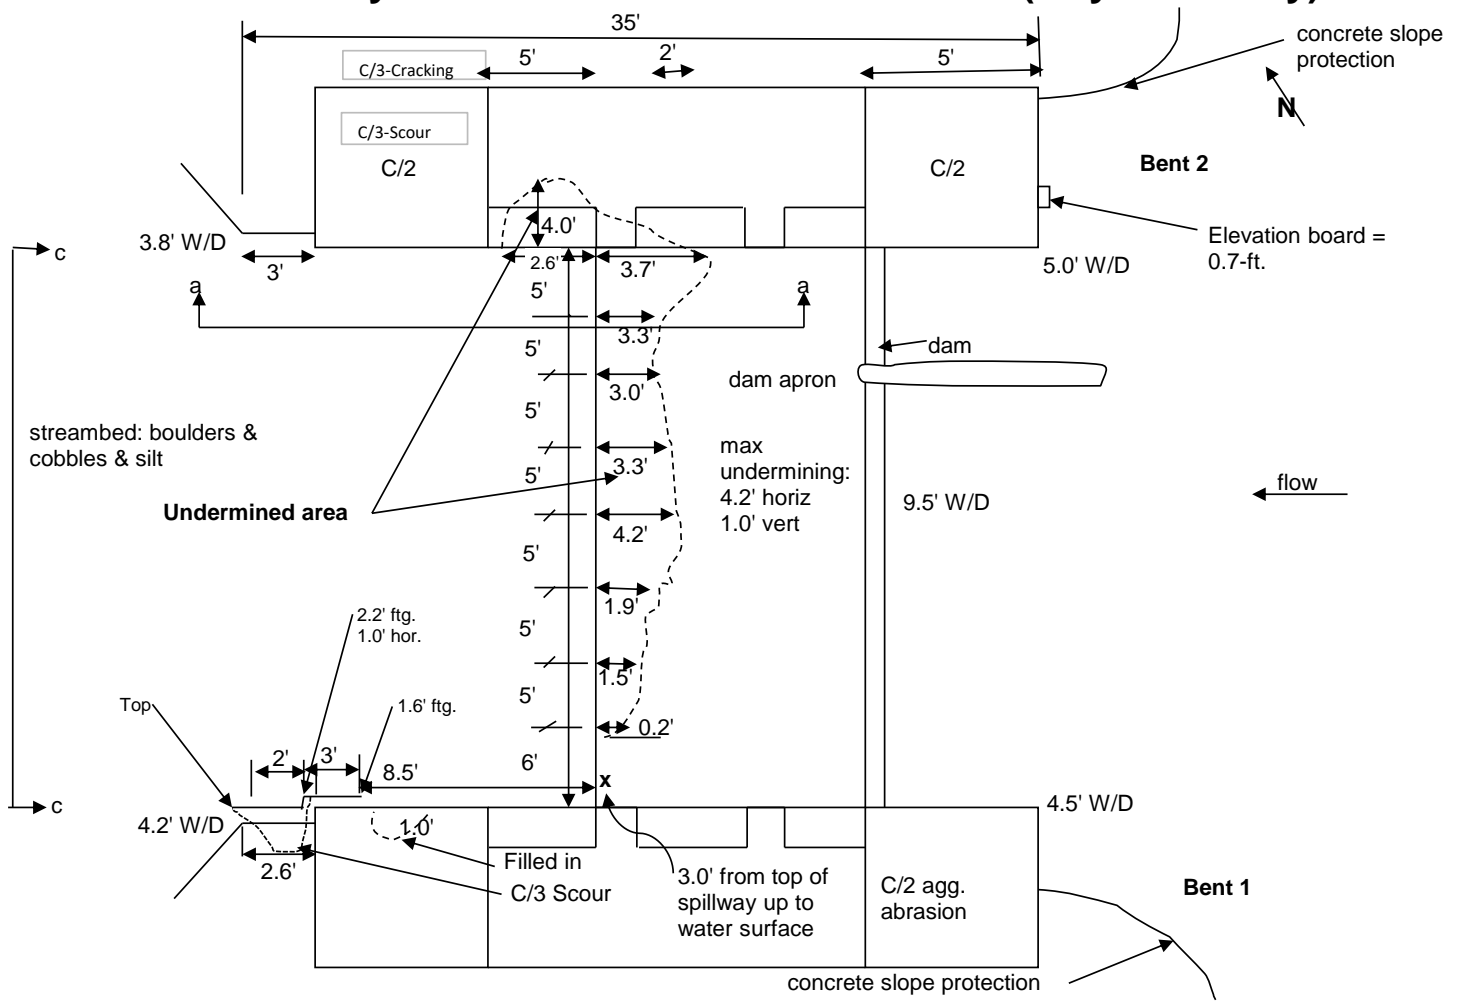
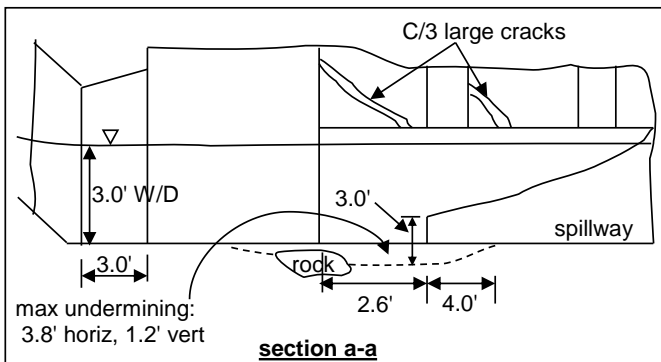
Bent	Elem.	Defect:
1	215	1120 The abutment has 3-LF of C/2 Efflorescence.
1	215	1180 The abutment has C/2 abrasion full length, due to hierarchy leaves 26-LF in C/2 Abrasion.
2	215	1130 There are two areas with C/3 cracking, see sketch. 7-LF total, but due to hierarchy with the cracks overlapping the scour only 2-LF of C/3 cracking.
2	215	1180 The abutment has C/2 abrasion full length, due to hierarchy leaves 27-LF in C/2 Abrasion.
2-3	221	6000 The edge of the dam apron that runs between the two bridge abutments is undermined full-length with a maximum of 4.2-ft. horizontally and 1.0-ft. vertical. No footing plans were available so spread footing sizes are an assumed perimeter length of 90-LF at each bent. Bent 1 has what appears to be 5-LF of footing edges exposed and Bent 2 has 7-LF of undermining (see sketch).

NBI Item BC 10 Widespread moderate and isolated major undermining of spillway.

NBI Item BC 11 Isolated major scour at Bent 2.

220 Some form of scour protection should be considered to prevent additional scour under the spillway apron and abutments.

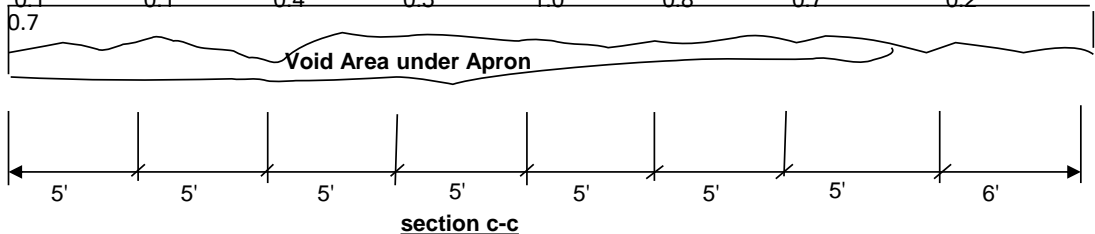
distance from top of apron down to streambed, bottom of apron is very irregular.	3.0'	3.2'	3.3'	3.4'	3.8'	3.4'	3.2'	2.9'	3.0'
horizontal amount of undermining	3.7'	3.3'	3.0'	3.3'	4.2'	1.9'	1.5'	0.2'	
vertical amount of undermining	0.1'	0.1'	0.4'	0.5'	1.0'	0.8'	0.7'	0.2'
