Staff Report

Historic Review of New Construction

HI-10-24

Preserving the Craftsman Character: A Proposal for Porch Restoration

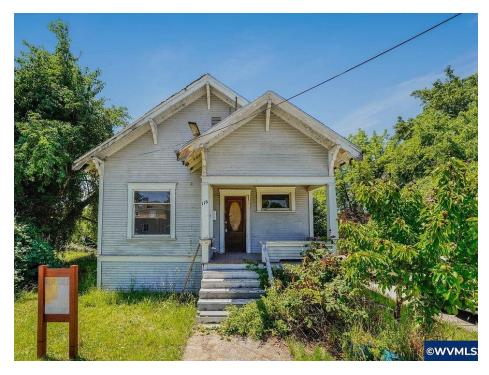
116 Cleveland SE Example property

• Although photographs of the original house are unavailable, a comparable property built by the same builder in the same year (116 Cleveland SE, Albany, OR) provides a reference point for the restoration design. Attached pictures showcase this comparable property.

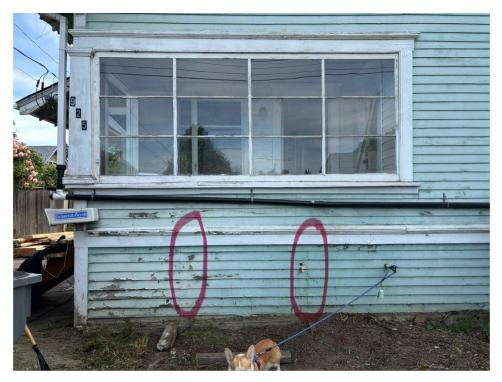
Evidence of step removal

- A defining characteristic of Craftsman houses is their use of tapered porch columns, typically made of wood.
- This proposal seeks to restore the original steps to their historic location, based on visible seams in the siding where the steps once connected.
- Additionally, new columns will be installed to match the existing tapered column, maintaining the handcrafted aesthetic.

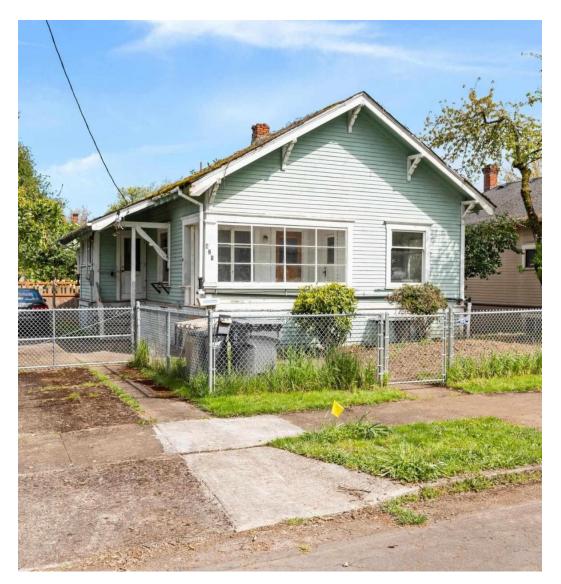
Subject property : 925 Walnut SW
